Manhole Inspection Summary

Manhole # S23MM_041MH

Insp Date: **7/4/05 9:36 PM**

Location Address: **2487 DRUID HILL AVE**

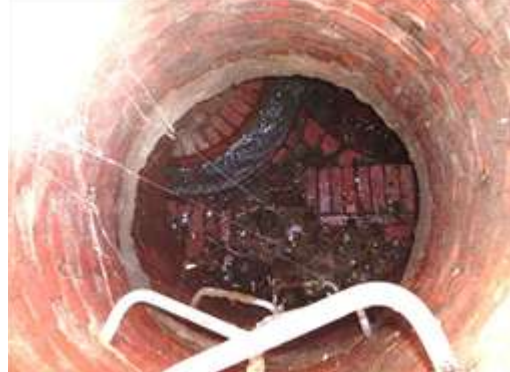
Top View

Corroded steps. Evidence of surcharge - Bench debris.

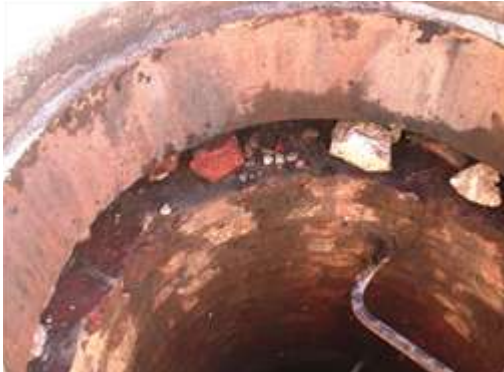
Defect

Frame leaks. Frame offset. Adjustment deterioration, loose brick and infiltration. Corbel infiltration.

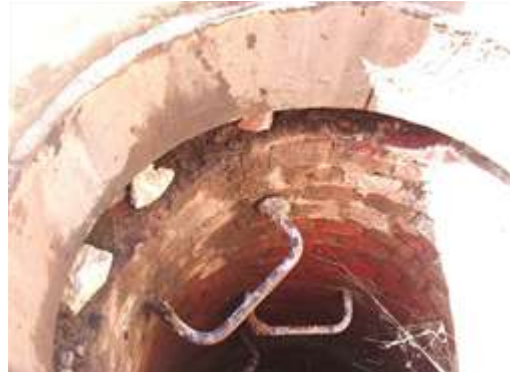
Defect

Frame leaks. Adjustment deterioration, loose brick and infiltration. Corbel infiltration.

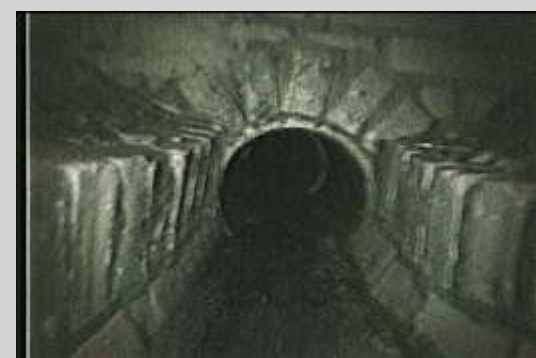
8 in. Circular Gravity Sewer Pipe Out @ 12 O'Clock

Deposits: ☐ None ☒ **Mud** ☐ Sludge ☒ **Debris** ☐ Grease

Silt Depth: **1** (in.) Deposits Extent: **Light**
